NASA CR-72485
PWA FR-3040

FINAL REPORT

FLOX/METHANE

PUMP-FED ENGINE STUDY

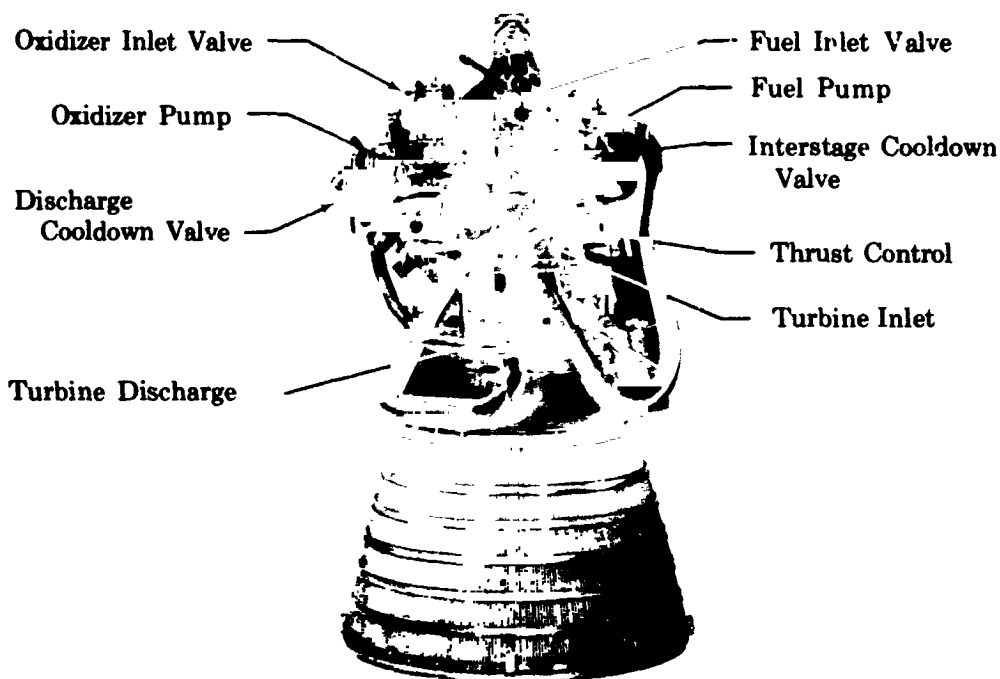
Figure 4. Pretest Photograph of Flox/Methane Engine FX-153, Build No. 3 FD 25709

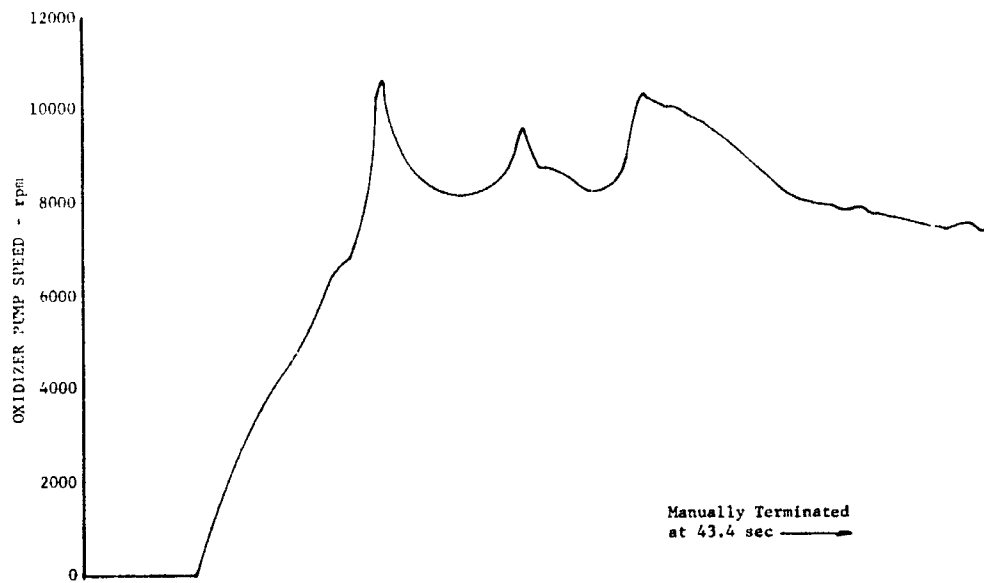
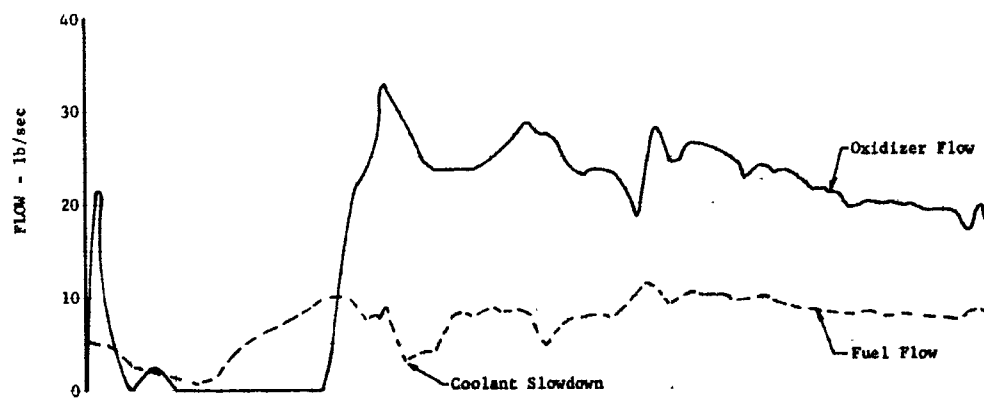
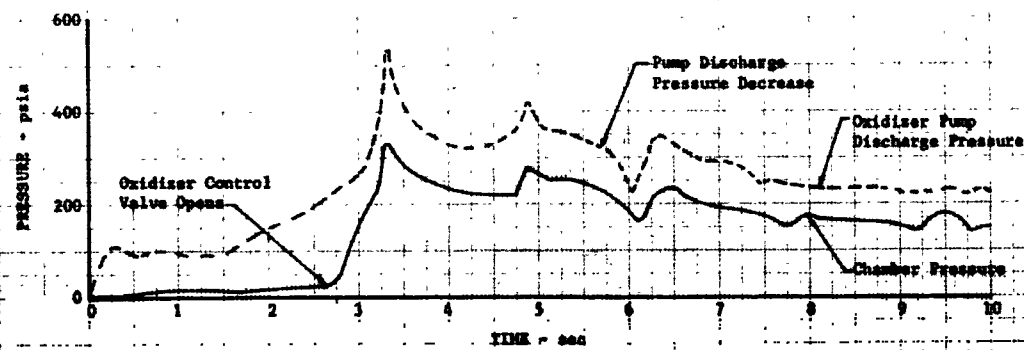
Figure 5. Starting Transient for Engine Test No. E-1

Although a reset system in the thrust control reacted to limit the acceleration, the chamber pressure overshoot to a peak value of 330 psia (at approximately 3.3 sec). This overshoot is greater than normal and apparently was caused by slower reaction of the engine system with flox/methane than with oxygen/hydrogen. Also, a tendency toward thrust control bypass piston sticking was indicated. Following the overshoot, a slight overcorrection reduced the chamber pressure to 220 psia (at 4.5 sec), followed by a slight overacceleration to 280 psia (at 4.9 sec).

The system appeared to be controlling at 260 psia chamber pressure at 5.7 sec, when the oxidizer pump discharge pressure suddenly decreased without a change in turbopump speed. When this occurred, the thrust control sensed the lower chamber pressure and accelerated the turbopump in an attempt to increase the flow. The oxidizer pump did not recover for approximately 3 sec. During this time, the turbopump started to decelerate; the system finally stabilized at 175 psia chamber pressure and a mixture ratio of 3.0 for the remainder of the test.

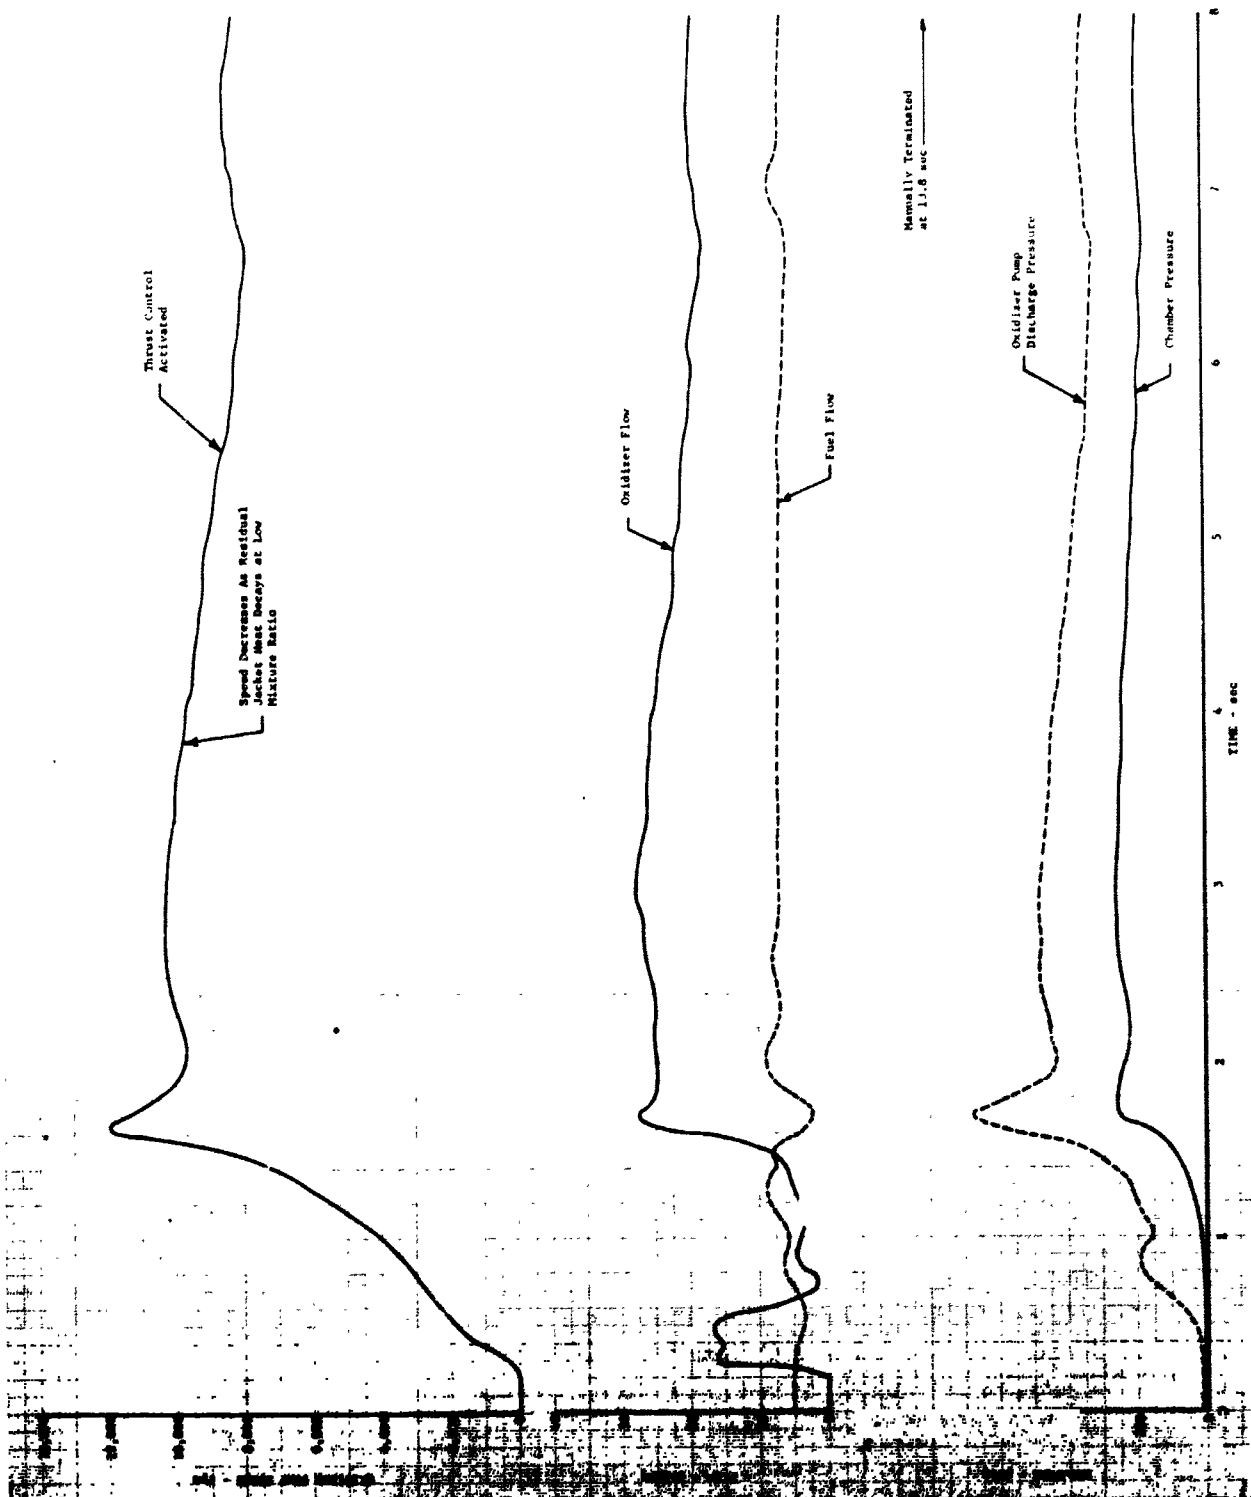
Figure 6. Starting Transient for Engine Test No. E-4

The engine stabilized at the design chamber pressure of 250 psia for 1.5 seconds at a mixture ratio of 3.6, after which the turbopump slowly decelerated. The reduced speed resulted in an oxidizer pump discharge pressure too low to keep the spring-loaded oxidizer control valve in its full open position. (It was predicted that the oxidizer control valve would not seat if the engine operated at a mixture ratio below 4.5, but cycle studies showed that, if all components operated as predicted, this would be achieved.) As the valve closed from the full open position it created a higher flow restriction, and therefore a reduction in mixture ratio, which further reduced speed. When the thrust control was activated at 5.5 seconds there was a temporary increase in rpm, but it was not sufficient to seat the oxidizer control valve and the system continued to decelerate. The test was manually terminated at 13.8 seconds; no hardware damage was found during the post-test inspection.

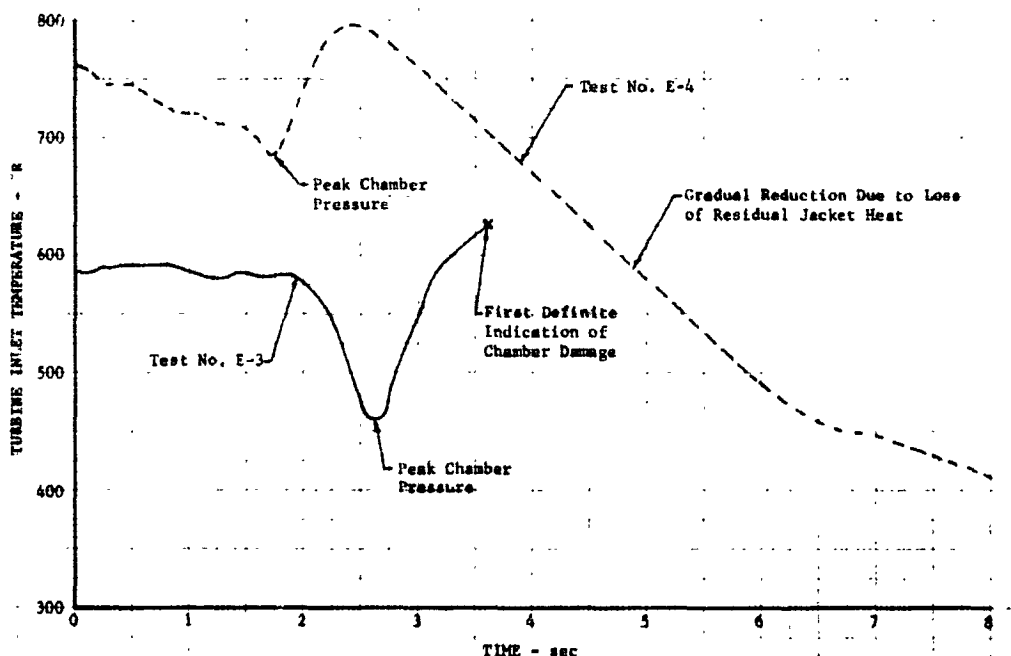
Figure 7. Turbine Inlet Temperature Comparison, Tests E-3 and E-4

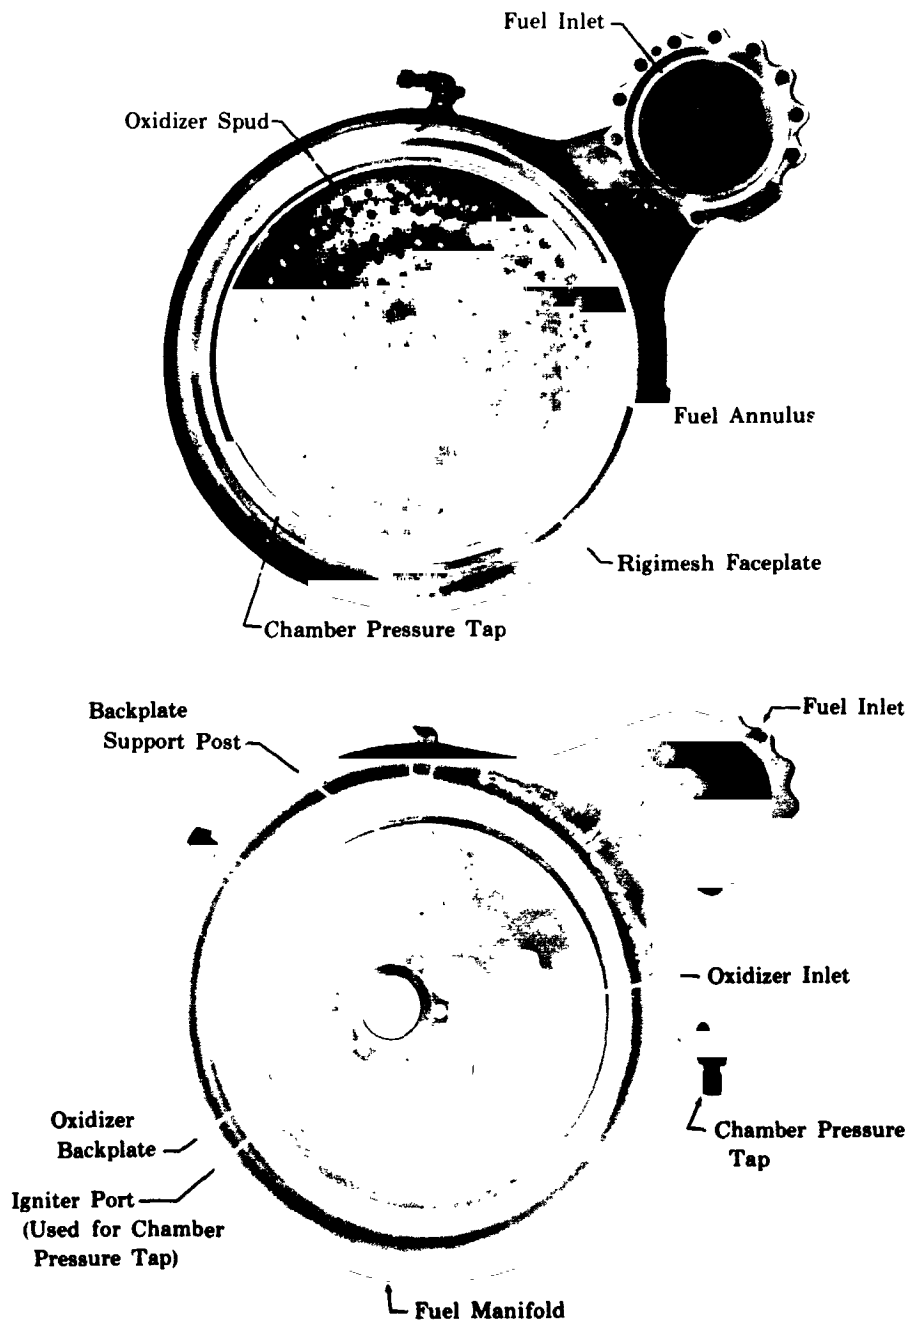
Figure 10. RL10 Injector External Features

injection elements, each of which consists of an oxidizer tube (or spud), and a concentric fuel annulus. The elements are arranged in concentric rows and inject in a direction perpendicular to the 15-degree conical face. The porous faceplate is fabricated from Rigimesh* and is transpiration cooled by the fuel. A cross section sketch showing construction features of the injector and its internal manifolding scheme is presented in figure 11.

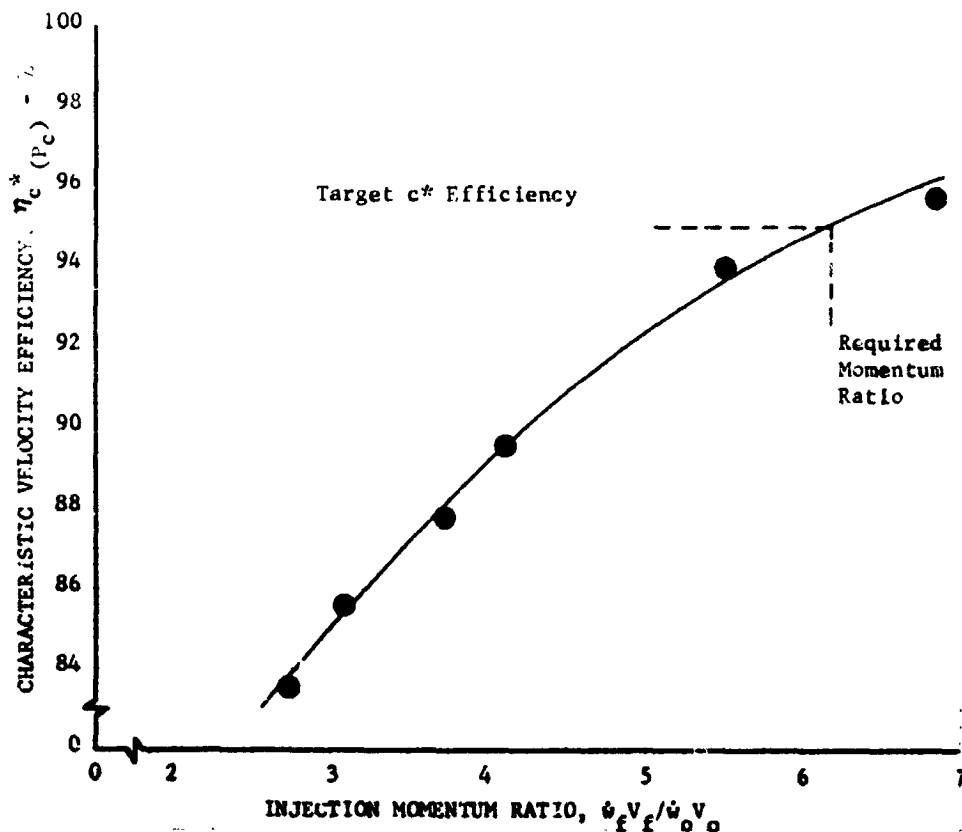
Figure 12. Variation in Characteristic Velocity Efficiency With Injection Momentum Ratio (Injector S/N HK 707)

At the nominal mixture ratio of 5.75, the c^* efficiency indicated for injector S/N HK 707 with flox/methane was approximately 84.5%, well below the target of 95%. The injection momentum ratio was calculated for each of the firings, and the plot of c^* efficiency vs momentum ratio presented in figure 12 was constructed. Based upon the momentum ratio to c^* efficiency relationship shown, a momentum ratio of 6.2 would be required at a mixture ratio of 5.75 to achieve 95% c^* efficiency. The 0.008-inch fuel annulus width of injector HK 707 provided a momentum ratio of 3.1 at the nominal mixture ratio; to achieve the higher level, a gap width of 0.004 inch would have been required.

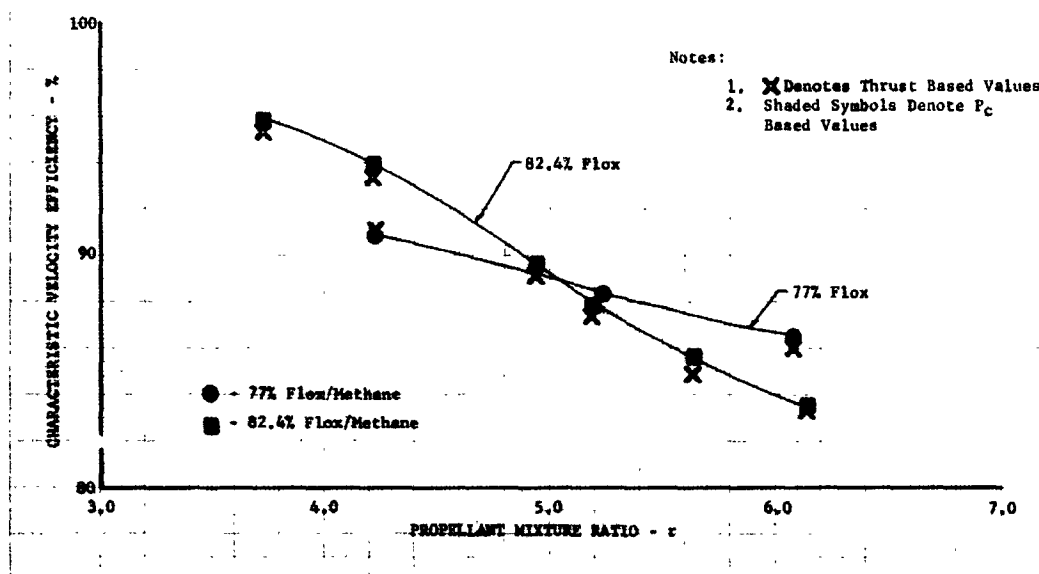
Figure 14. Comparison of Injector S/N HK 707 Characteristic Exhaust Velocity Efficiencies at Different Flox Concentrations DF 69052

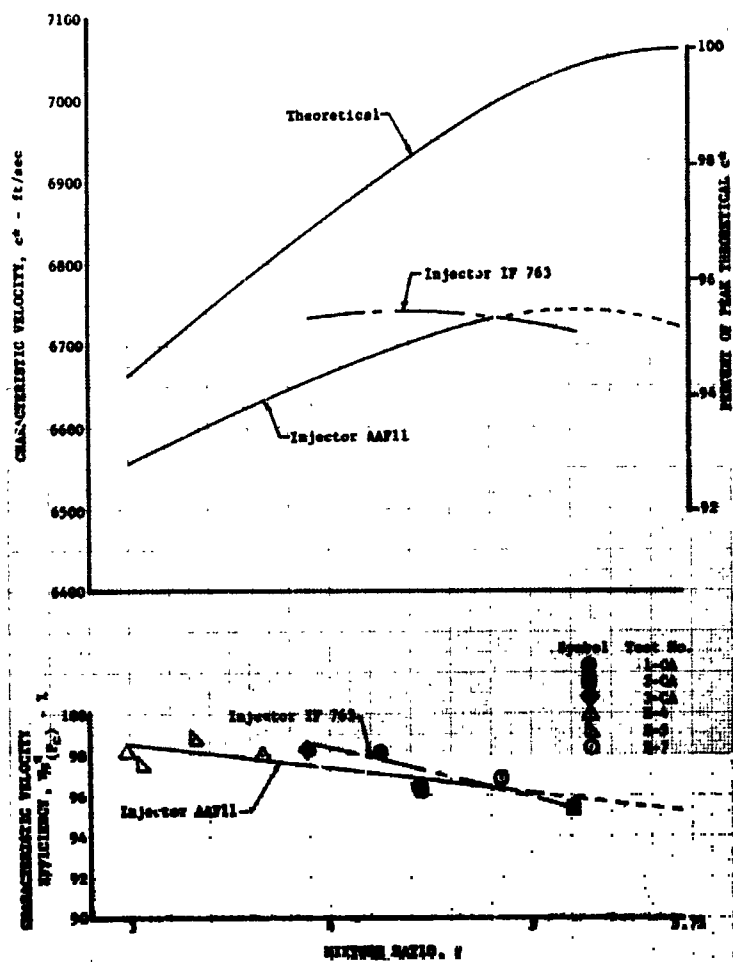
Figure 20. Characteristic Exhaust Velocities, Injectors S/N IF 763 and S/N AAF 11

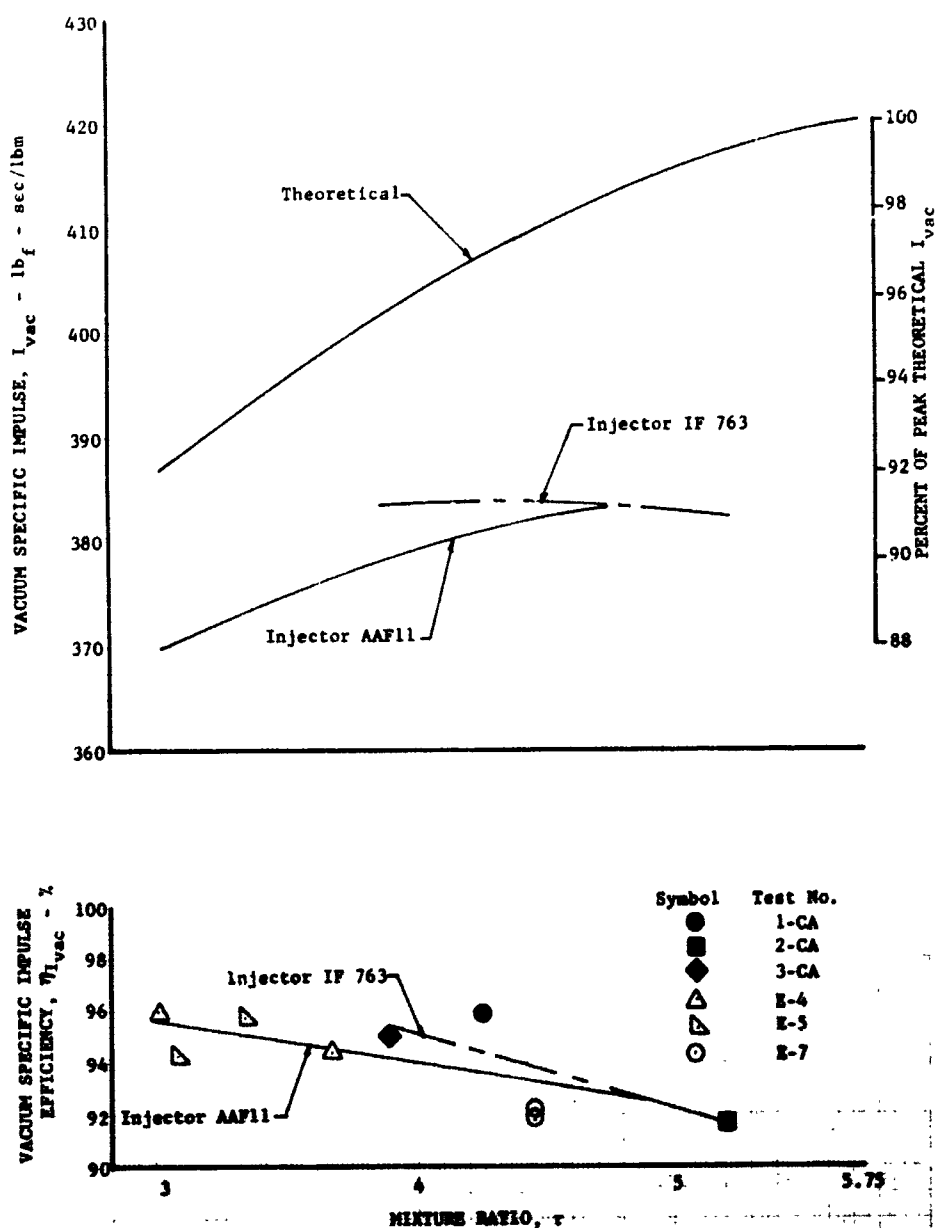
Figure 21. Vacuum Specific Impulse, Injectors S/N IF 763 and S/N AAF 11 DF 69064

Figure 21 displays the vacuum specific impulse efficiency obtained with the two highest performing injectors. The absolute value of impulse that these efficiencies would provide when referenced to the standard normal boiling point liquid propellant inlet conditions is also shown. Both injectors produced maximum impulse at a mixture ratio below the theoretical optimum. Based on the standard propellant inlet conditions, the maximum specific impulse demonstrated with the area ratio of 40 nozzles was 384 seconds (injector S/N IF 763).

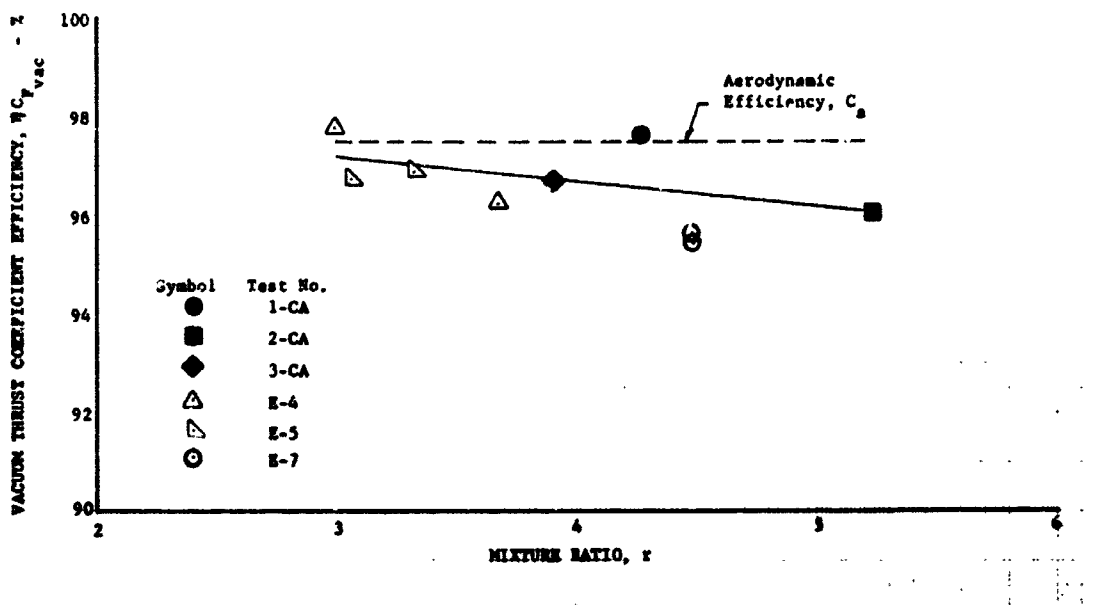
Figure 22. Experimental Vacuum Thrust Coefficient Efficiency

Vacuum thrust coefficient efficiencies for the thrust chamber are presented in figure 22. The dropoff that occurs with increasing mixture ratios is attributed to two phenomena: (1) kinetic losses, and (2) a decrease in the theoretical C_F due to mixture ratio variations within the exhaust gases. Theoretical thrust coefficient losses due to kinetics have not been calculated for flox/methane at the conditions of the tests. Low chamber pressure flox/methane data (References 2 and 3) indicated that the kinetic losses predicted by the present methods are from three to five times higher than the experimental losses. A NASA funded program (Reference 5) is now in progress at the United Aircraft Corporation Research Laboratories to identify the important rate limited reactions and to generate a correlation with available experimental data. With respect to mixture ratio variations, the possibility of C_F efficiency losses because of nonuniform mixture ratio profiles was established in Reference 6, but the magnitude of such losses cannot be determined without specific knowledge of the mass flow-mixture ratio distribution.

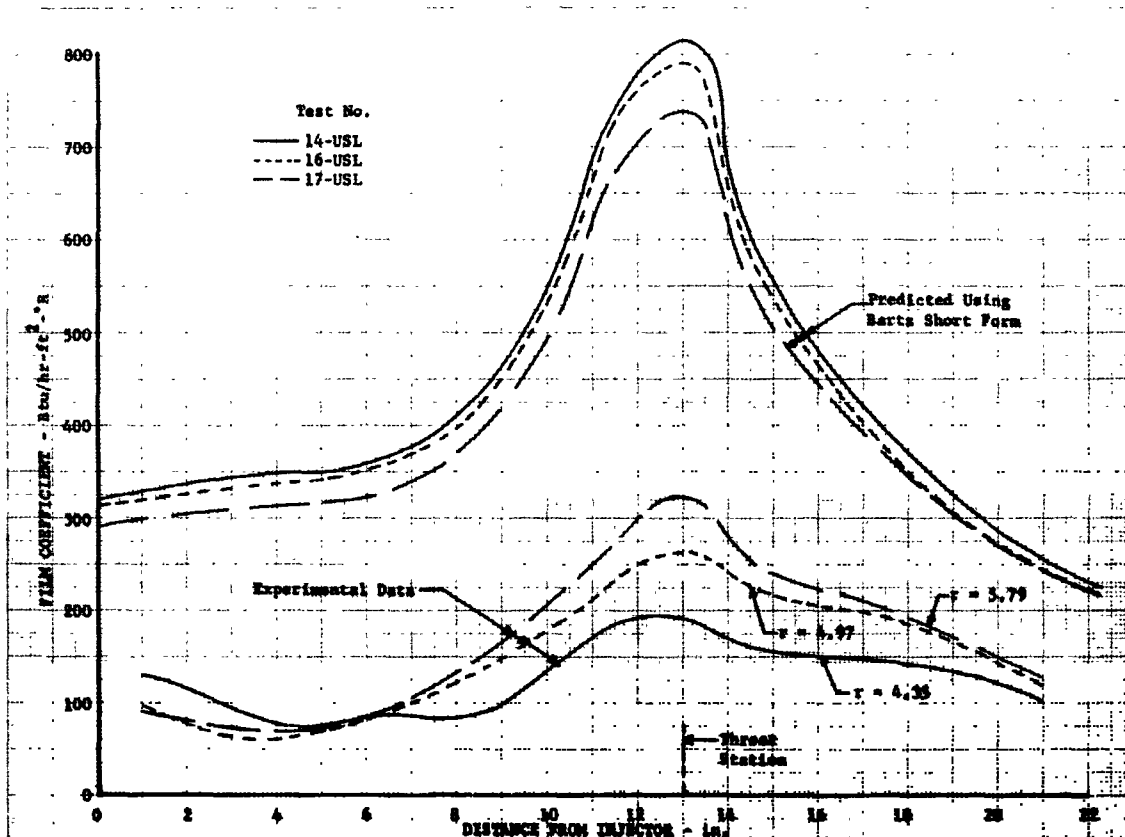
Figure 28. Comparison of Measured and Experimental Heat Flux For Injector S/N IF 764

Combustion side film coefficients predicted using the Bartz short form (Reference 8) are compared with experimentally-determined longitudinal film coefficients in table XI. The experimental film coefficients in the combustion section were consistently between 20 and 50% of the predicted values, with the maximum film coefficient occurring at, or slightly upstream of, the throat. A graphic comparison of predicted and experimentally determined longitudinal film coefficients obtained with injector S/N IF 764 for three different mixture ratios is presented in figure 28.

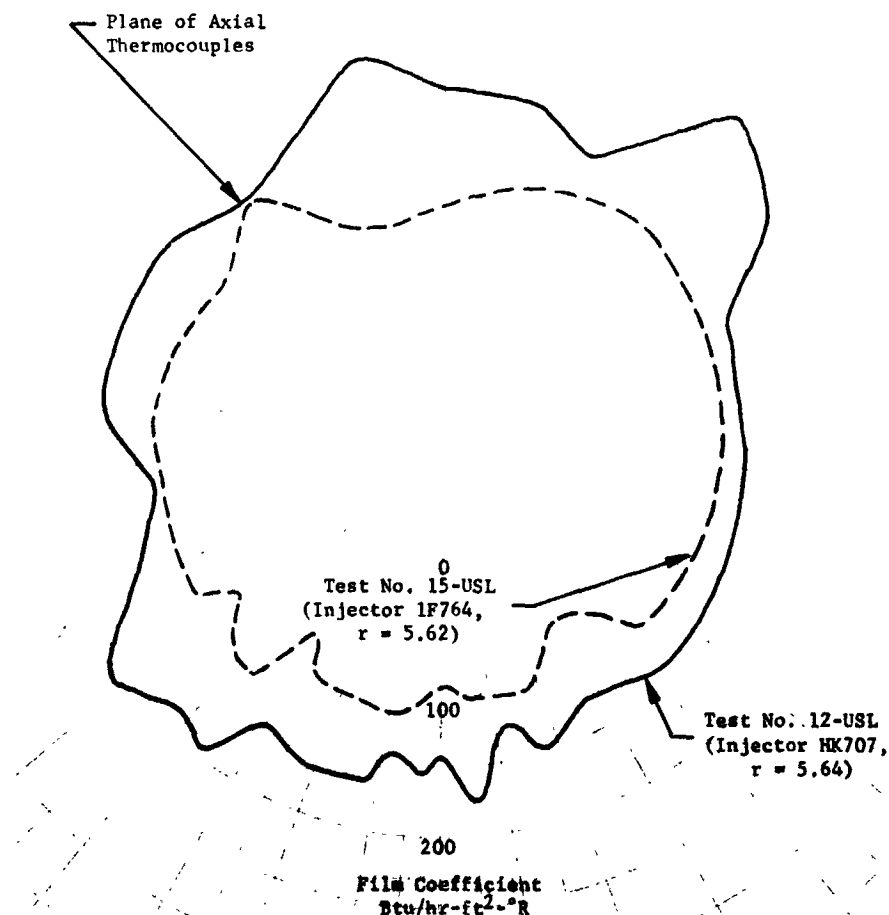
Figure 29. Circumferential Heat Flux Variation in Uncooled Chambers: Data Taken 1.08 Inches from Injector Face DF 69061

Figure 29 shows the circumferential heat flux variation measured with two injectors, S/N HK 707 and S/N IF 764, each at a mixture ratio near the theoretical optimum of 5.75. Although the coefficients determined from circumferential instrumentation in the radial plane of the longitudinal thermocouples agree favorably with the values obtained from the longitudinal instrumentation (within 4%, 107 to 103 btu/hr-ft²-sec), a circumferential variation of nearly 100% was found for both injectors.

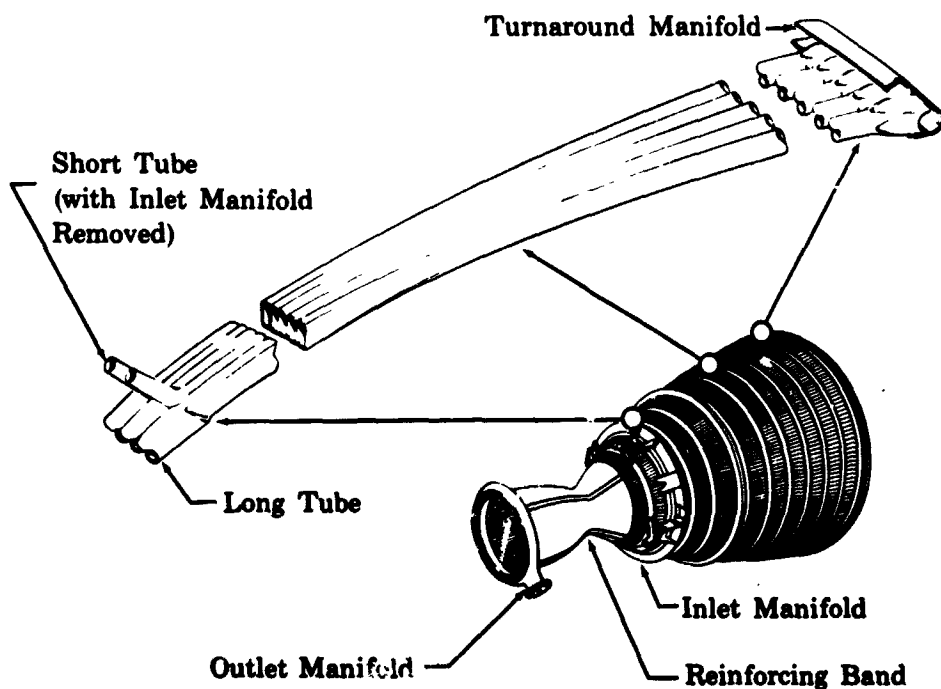
Figure 31. RL10 Thrust Chamber Configuration

end, giving the tube a venturi shape. The "single-tapered" short tubes increase in diameter from the pocket inlet manifold to the nozzle exit section. The chamber is formed by furnace brazing the tube bundle and a reinforcing jacket is used to strengthen the combustion chamber and throat region. The dimensions of the chamber are shown in figure 32.

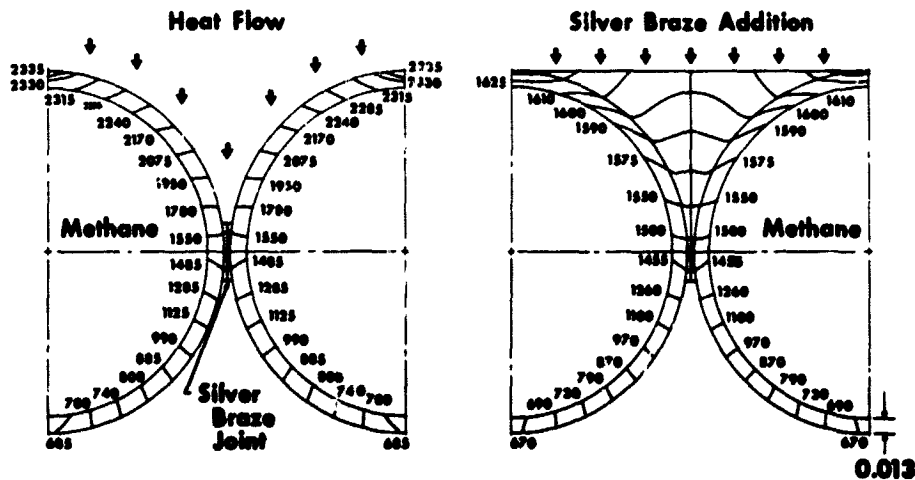
Figure 33. Effect of Filler Braze on Temperature Distribution in Tube Walls GS 7905

The first modification tried in the transition region was applying a high-conductivity silver-braze material to fill the root area between tubes. The filler material provided a conduction path into the root zone to reduce crown temperatures. The calculated effect of braze addition on tube wall temperature distribution is shown in figure 33. The diagram on the left shows wall temperature isotherms predicted in the transition region in the Bill-of-Material configuration. The diagram on the right shows the predicted temperature distribution with braze addition. A reduction of crown temperature from 2492°R to 1630°R was indicated by calculations, but in actual application it was found that the filler braze was subject to erosion and that other techniques for modification were required.

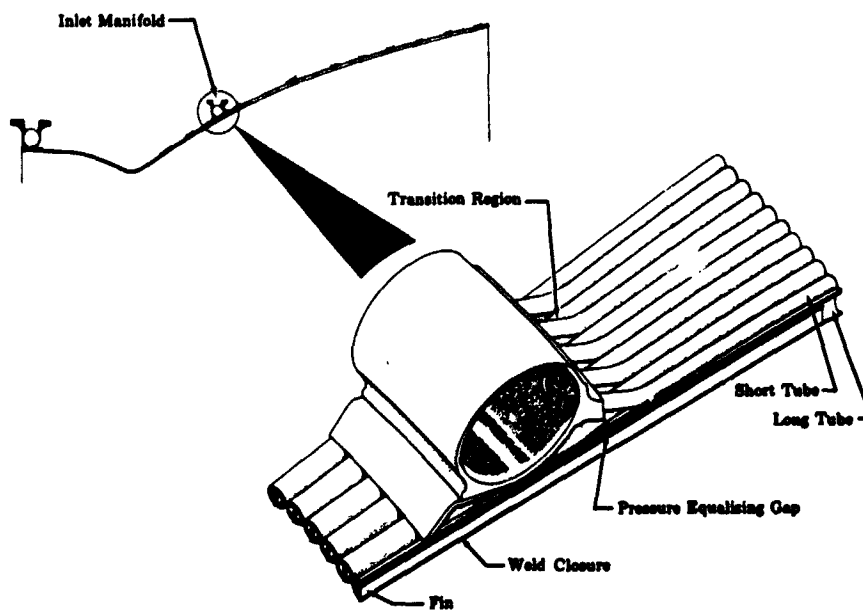
Figure 34. Fin Installation in RL10 Chamber Nozzle

ing the modification is presented in figure 34. This alteration improved tube durability in three ways; (1) the coolant side film coefficient was increased because of the higher coolant velocities caused by the flow area blockage; (2) the heat transfer rate to the coolant was increased because of the larger conduction area provided by the fins; and (3) hoop stress at the tube crown was reduced because of the increased wall thickness produced by the welding operation.

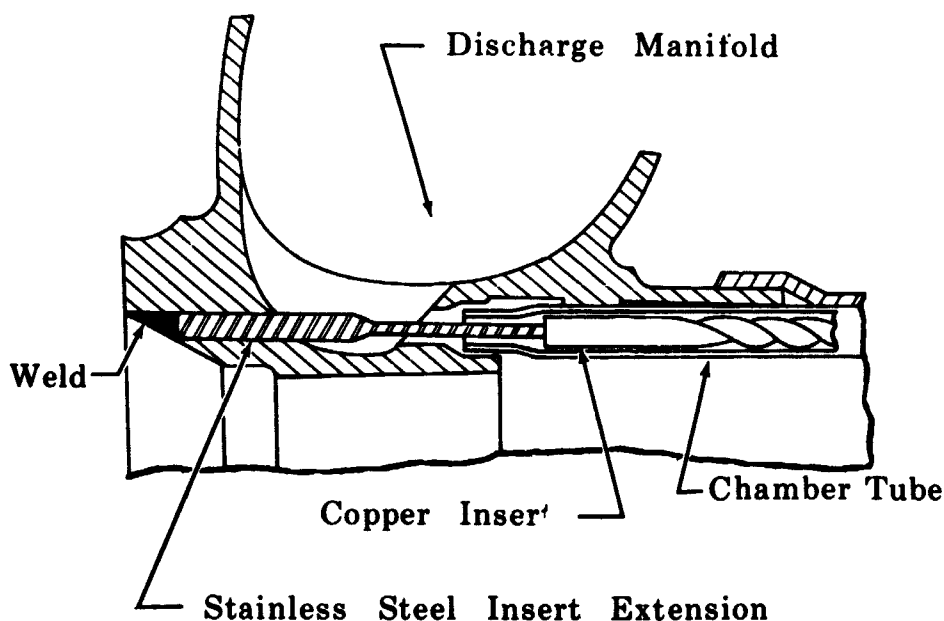
Figure 35. Tube Insert Installation in Combustion Chamber

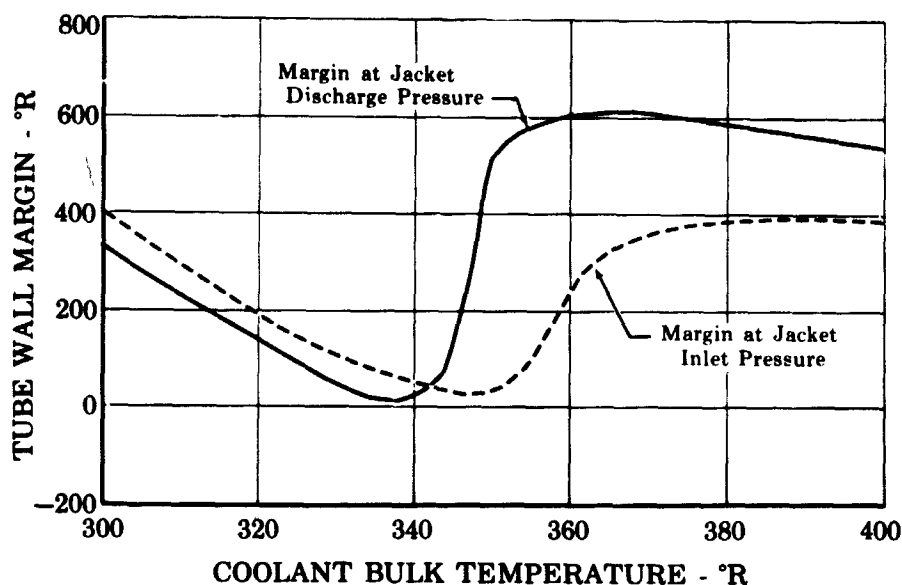
Figure 37. Predicted Variation in Tube Wall Margin With Coolant Bulk Temperature at Point of Failure in Test No. 3-CA FD 25628

* Wall margin is defined as the difference between the predicted tube operating temperature and the temperature at which the calculated tube hoop stress equals the 0.2% yield stress of the material.

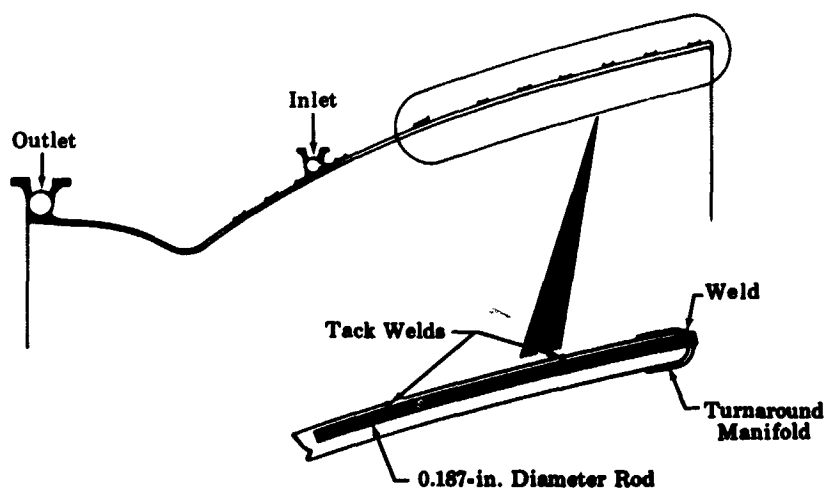
Figure 38. Rod Installation in Chamber JP88 Nozzle

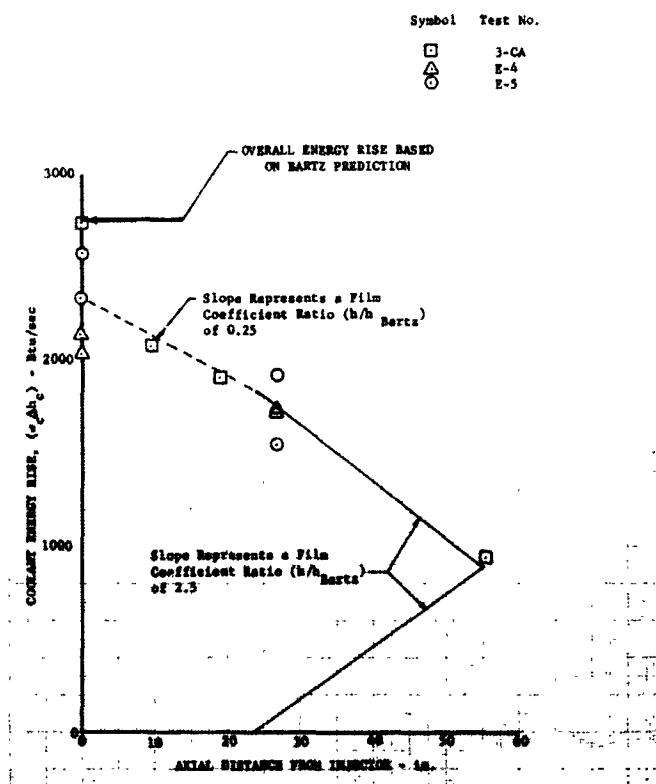
Figure 39. Coolant Energy Rise

The unique indication of figure 39 is that the heat transfer rate downstream of the transition region is approximately 2.5 times higher than the theoretical value. Based on the data from test 3-CA, in which the thrust chamber was most extensively instrumented, approximately 80% of the heat transfer occurred in the nozzle downstream of the throat. While the bulk temperature thermocouples used were subject to some conduction errors because of the method of installation, and there were also circumferential heat flux variations, these factors could not reasonably explain a difference of this magnitude. This result is also substantiated by the fact that when the high indicated value of nozzle heat transfer is subtracted from the well defined overall heat transfer rate, the resulting chamber heat flux is shown to be about 25% of theoretical, which compares favorably with that calculated using experimental film coefficients obtained in the uncooled tests.

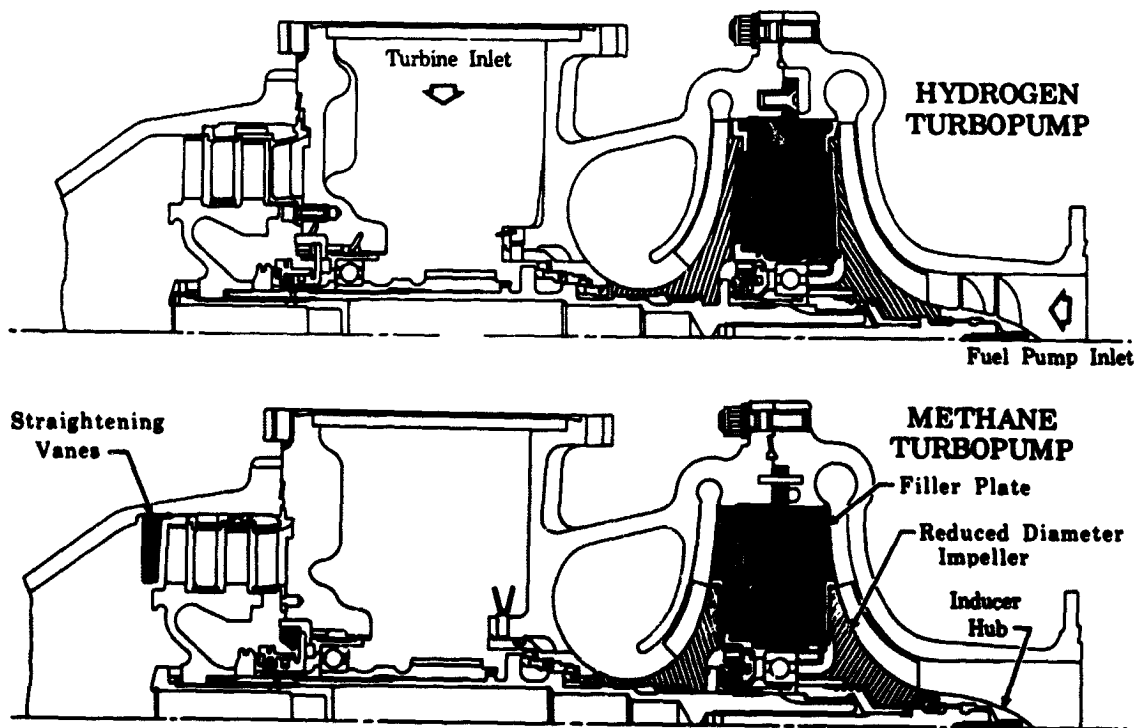
Figure 41. Comparison of Hydrogen and Methane RL10 Turbopump Assembly

The modified pump is compared to the standard RL10 hydrogen pump in figure 41. The modified impellers were sized at 4.25 inch-diameter for both stages, based on a head coefficient of 0.495 and a shaft speed of 19,926 rpm. Filler plates were added to the bearing support to fill the voids left by the reduced diameter impellers, and thereby to maintain smooth flow passages that would reduce possible head losses. No changes were made to the bearings, seals, or the fuel distribution system for gearbox cooling.

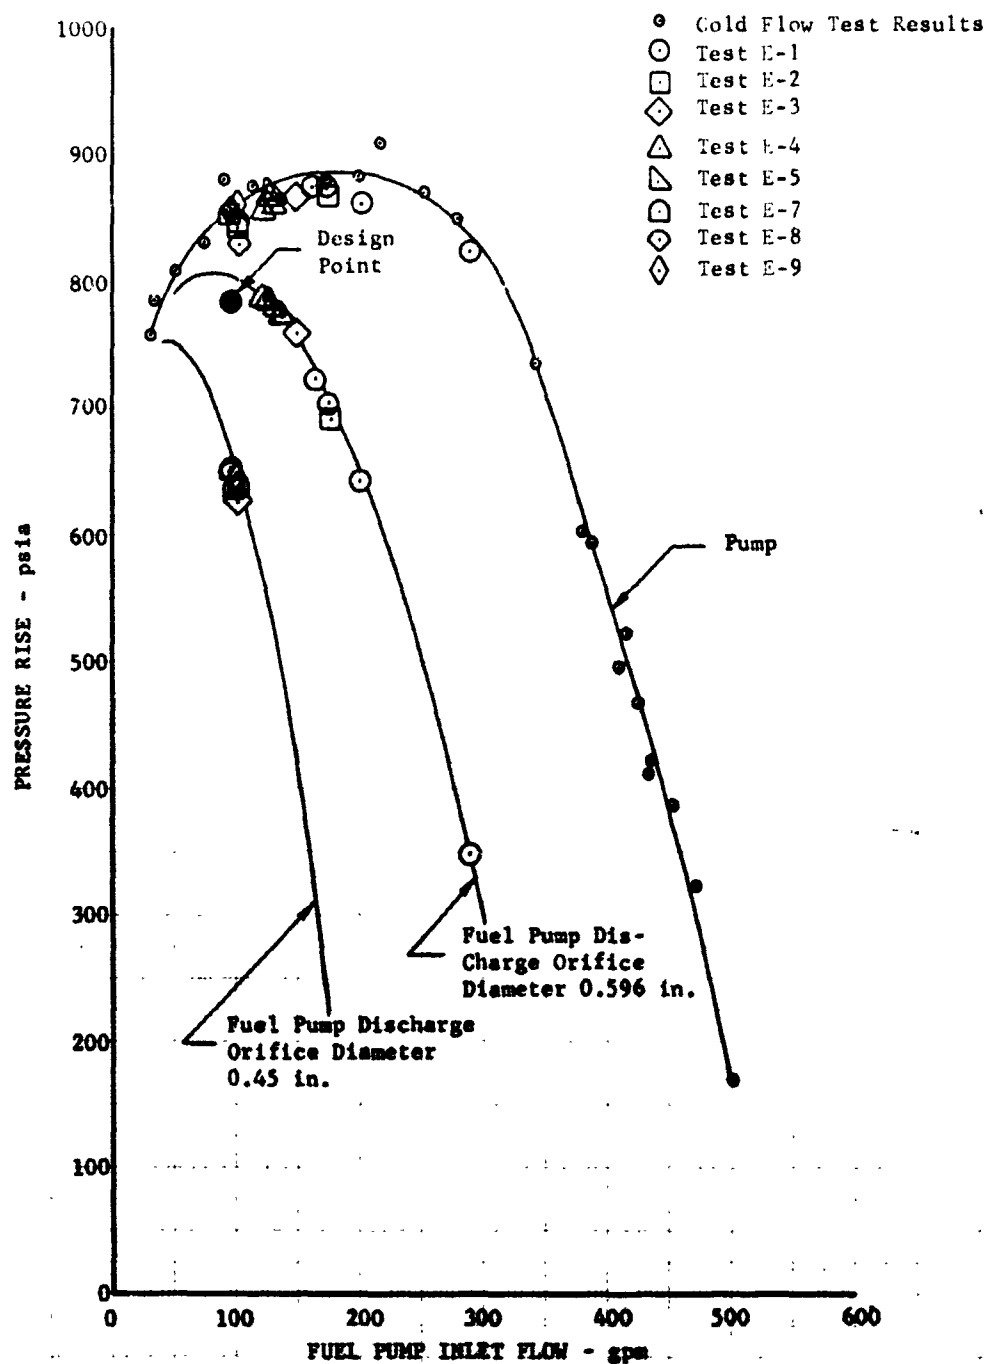
Figure 13. Pressure Rise Characteristics of Methane Modified RL10A-1 Fuel Pump; 20,000 rpm

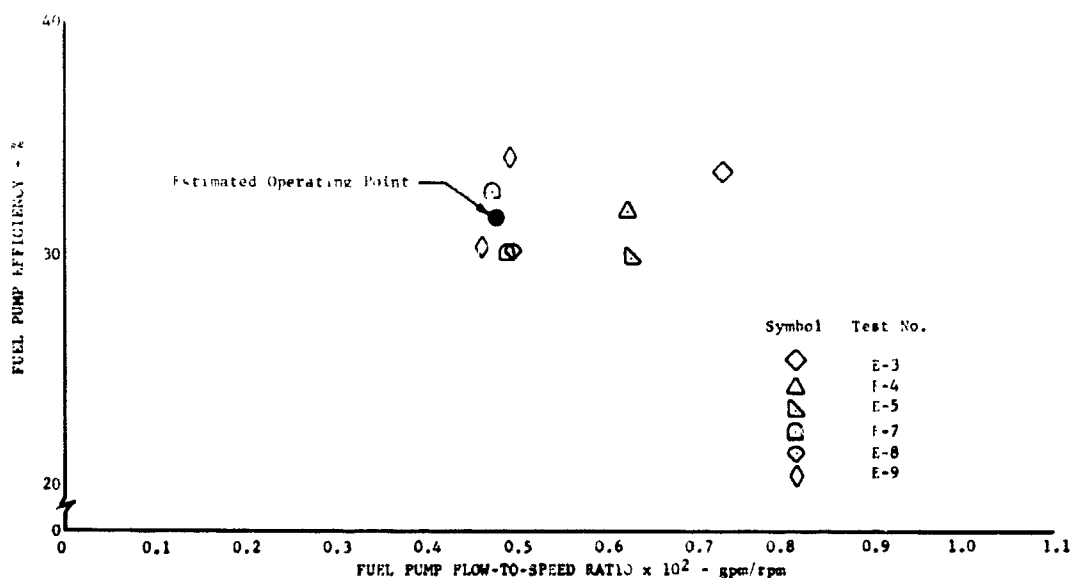
Figure 44. Variation in Efficiency With Flow-to-Speed Ratio for Methane Modified RL10A-1 Fuel Pump

optimum configuration of the highly modified pump and was predicted before testing. Pumps designed specifically for these conditions should have an efficiency closer to the "Worthington" value.

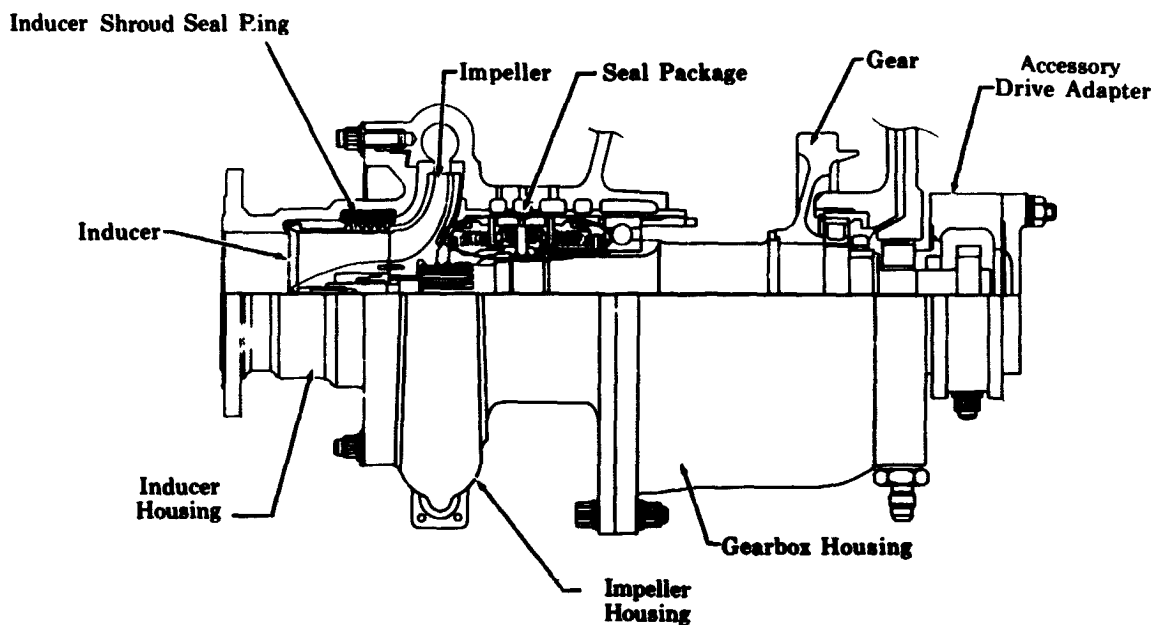
Figure 45. RL10A-1 Oxidizer Pump

having a fully shrouded impeller and shrouded axial inducer. Labyrinths are incorporated at the inducer shroud to minimize flow recirculation. Radial blades are used on both the front and rear impeller shrouds to reduce thrust loads on the shaft. The pump shaft is supported by a ball bearing located in the impeller housing behind the dynamic seals, and a roller bearing located in the gearbox housing. The drive gear is located between the bearings, both of which are cooled by fuel which is tapped off of the first stage housing, approximately at the midpoint of the impeller.

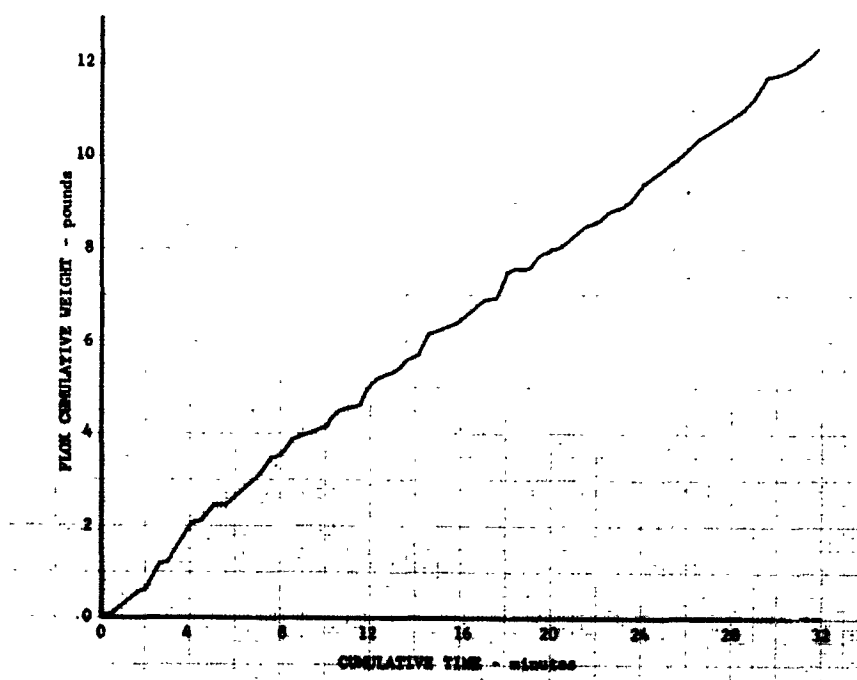
Figure 47. Variation in Cumulative Flox Leakage With Operating Time **DF 68907**
